***Preliminary Assessment and Recommendations for
Conservation and Enhancement of
St.Ines- Campal Creek and the Historic Bridges***

Goa Heritage Action Group

11th June 2021

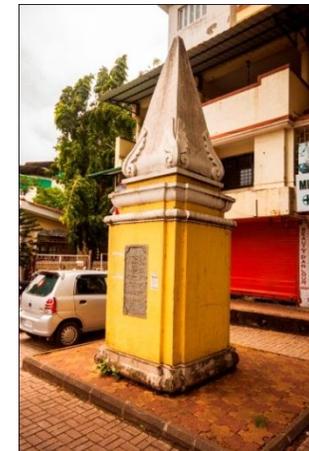
Tonca Pillar and was rebuilt and restored in 2004 by GHAG

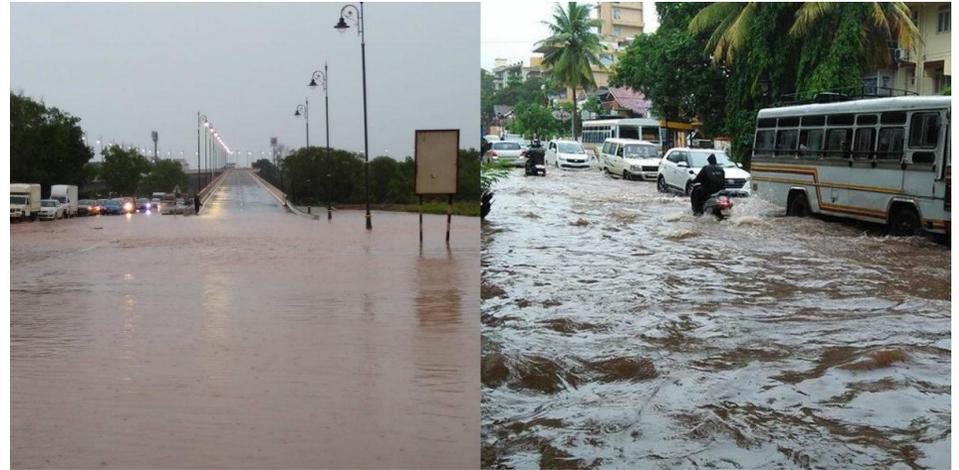
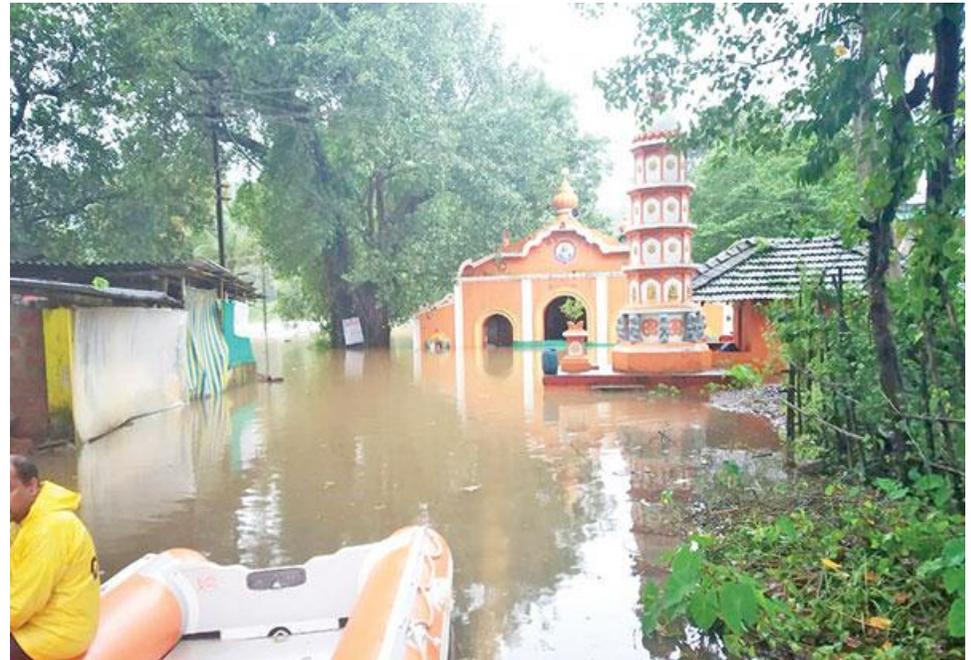
- Rapid and often indiscriminate urbanisation of Caranzalem and Taleigao has adversely impacted the rain water egress for the entire valley that is shadowed by Alinho Hill and Dona Paula Hill. The impact is perennial flooding of Panaji city which is at the lowest end in the North.

- The Nature and Gradient of land does not adhere to administrative boundaries and thus the St. Ines creek needs to be Conserved and Rehabilitated to serve efficiently as the primary mitigation instrument of effective draining of rainwater.

- Waste Water mismanagement has rendered the Creek as a nullah and not a rain- water- drainage instrument that it was designed for that also experienced and facilitated the khazan agricultural practices through the tidal action.

- Climate change crisis will be felt very severely in the capital city as the sea level rise will further impact the city water drainage systems in coming decade. Impact is already experienced since last few years.

- It is imperative that a holistic approach is adopted in treatment of the Conservation of the St. Ines Creek.
- The invert levels need to be established afresh through the entire length of the creek.

- Dredging and cleaning it of all debris and waste will be requisite to know of the scope of work.
- The surviving retaining walls must be repaired and restored while the missing walls should be constructed anew – such as those near the STP towards East and West from the junction at Thomas Garage Bridge.

- Each of the households and other properties that are discharging their waste water into the creek should be identified and notified for remedial action. This anomaly is a health hazard via mosquito and flies borne diseases to name just few- for the entire city and must be treated as such. Creek must be restored to its original tidal water channel and not a nullah.

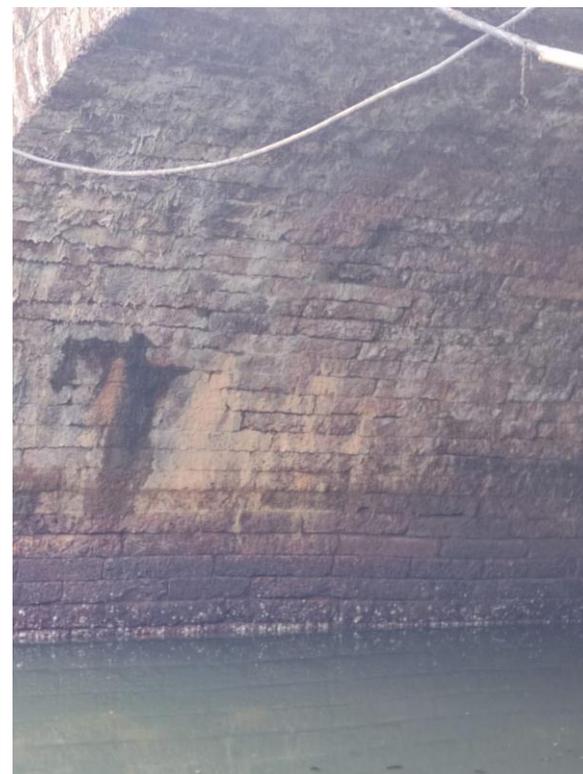
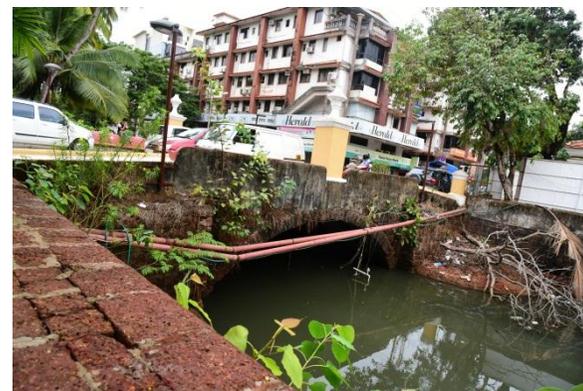
Assessments	Recommendations
<p>The Sub Structure:</p> <ul style="list-style-type: none"> • The dredging will reveal the status of foundations but as far as one can see, the masonry appears to be sound. • The soffits of the bridges need to be inspected. 	<ul style="list-style-type: none"> • Post dredging, detailed survey must be undertaken to record the status of the structure. Only then – detailed report of action required could be framed. • Preliminary survey suggests that cleaning of the stones, consolidation of the stone masonry where flaking should be undertaken. • Raking and pointing the stone masonry employing shell slaked lime, sand and surkhi mix is strongly recommended as it will enhance the life of the masonry bridges.

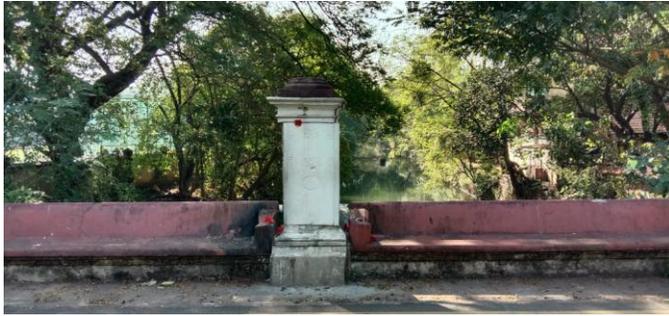
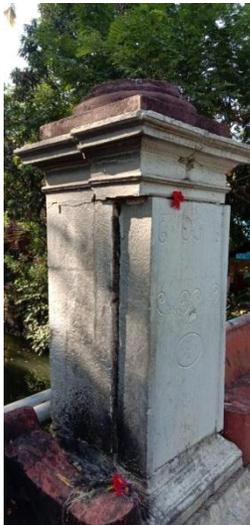
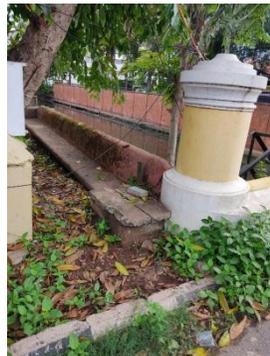
- The routine surfacing with tarring has caused much harm.
- The edges with period architectonics in form of benches and columns have suffered neglect and are damaged

- The length of the bridge must be carefully ascertained to ensure that once the resurfacing of the bridge is undertaken , the buffer at two ends allow for tar road to end in splayed joint.

- The tar surface should be completely removed.
- The revealed masonry should be examined and consolidated and then after establishing proper slope and grading, can be given rich concrete surfacing on sound foundation of adequate thickness. After adequate curing, the finishing in 10cm by 10 cm granite cobbles in grey and black with a pattern for visual quality be installed.

- On either side, minimum of 2 ft. of pathway should be provided and granite curb stones can help in segregating this pedestrian zone to make it safe.
- All of the features- the benches, the columns, the balustrades should be repaired or rebuilt if beyond repair in same style.

- All plants and weeds that are threatening the structure should be removed. In consultation with the structural engineer and a horticulturist , areas should be marked on site as no plants zone and be paved in concrete with proper slopes for effective drainage.

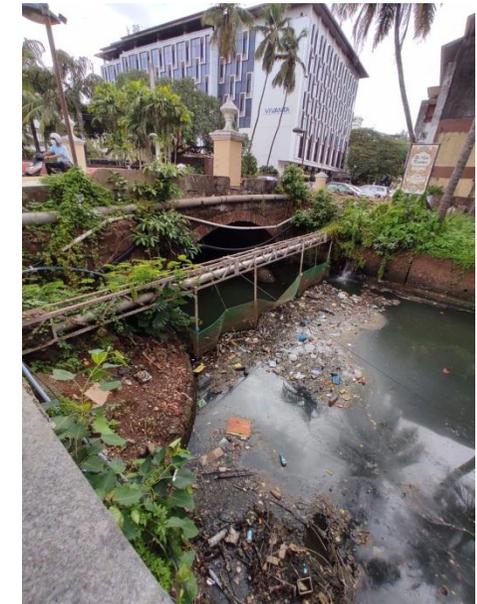
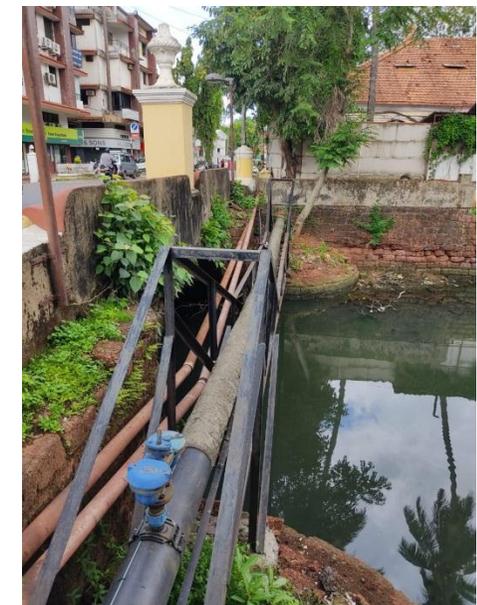
Rapid Assessments	Recommendations
<p>The services</p> <ul style="list-style-type: none"> Over the period, services like water pipes, electrical cable, communication cables have been laid with little to no respect towards the significance of the bridges. 	<ul style="list-style-type: none"> All services should be resolved before the resurfacing. Thus to resolve the issues, the Detail Proposal report on the rehabilitation of the Bridge edges must have inputs from the various departments of Services. All should be resolved as these are the major cause of visual blight and are also causing stress to the sanctity of the structures. It is also desirable that to avoid repeat of any such blight, the PWD Executive Engineer must mandate to all other services departments to obtain an NOC from PWD in advent of any future interventions. This also means that not only the services as existing should be resolved but also future needs should be ascertained and provided for in advance.
