***Preliminary Assessment and Recommendations for
Conservation and Enhancement of
St.Ines- Campal Creek and the Historic Bridges***

Goa Heritage Action Group

11th June 2021

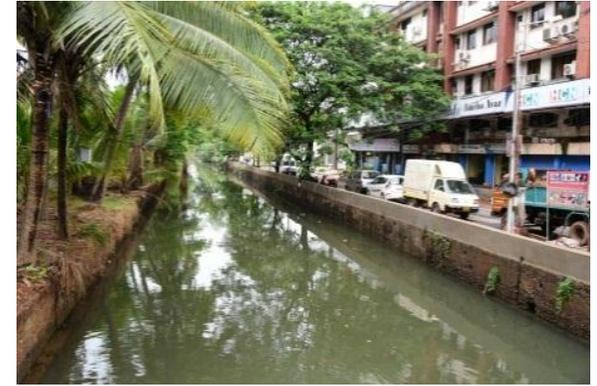
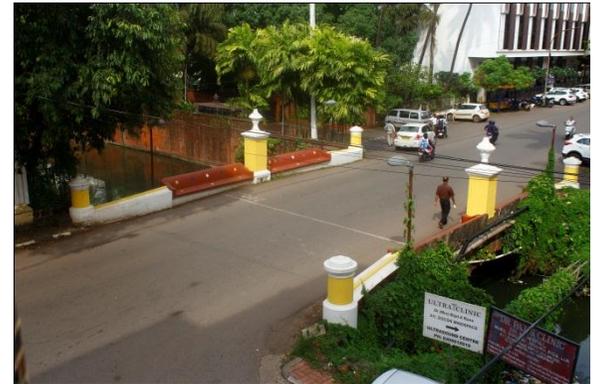
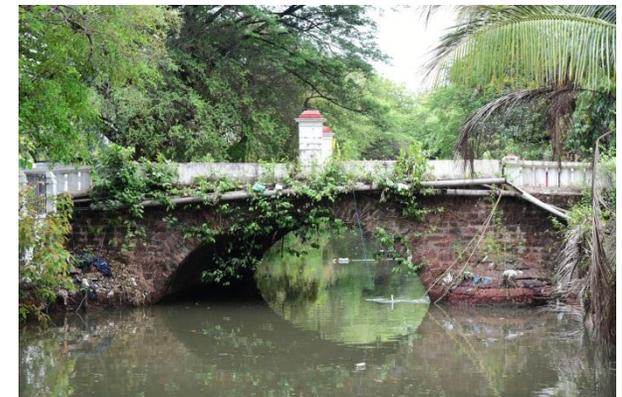
Minerva Bridge (near INOX)

Ponte de Portugal (near Vivanta- Campal)

Tonca Bridge or Old Bridge at the STP and Thomas Garage Junction
